DW TECH BULLETIN

DOC #: DW10052011
Distribution: Internal

subject: Weak Video Signal Side Effect

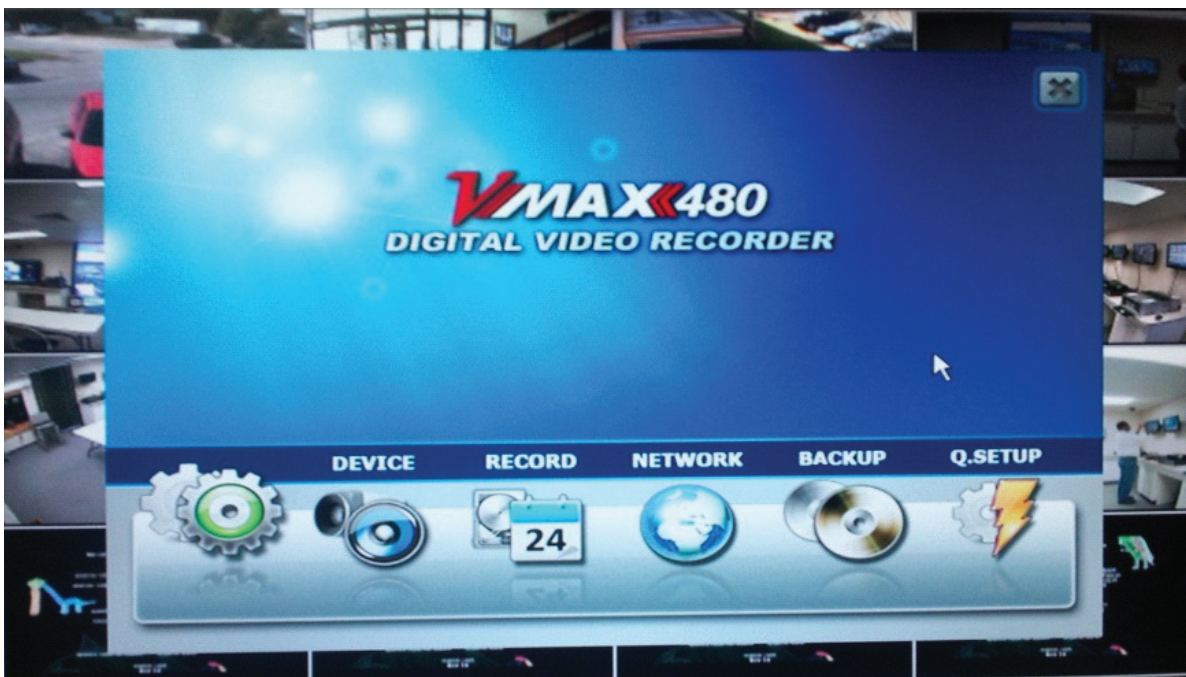
When a weak or noisy video signal is connected to the VMAX Series digital video recorder, the user will experience a random reboot or no recording.

What is weak video signal? It is when the video signal level is less than 1 Volts peak to peak (1Vp/p) or when the video image on the monitor contains a lot of noise or flickers excessively.

When you receive a call that the VMAX Series DVR is not recording or rebooting, ask the customer about the quality of the live video on the monitor.
